**SITE ASSESSMENT REPORT
FOR
LEFTON IRON & METAL
TDD: T05-9107-019
PAN: EIL0746SAA**

JANUARY 13, 1992

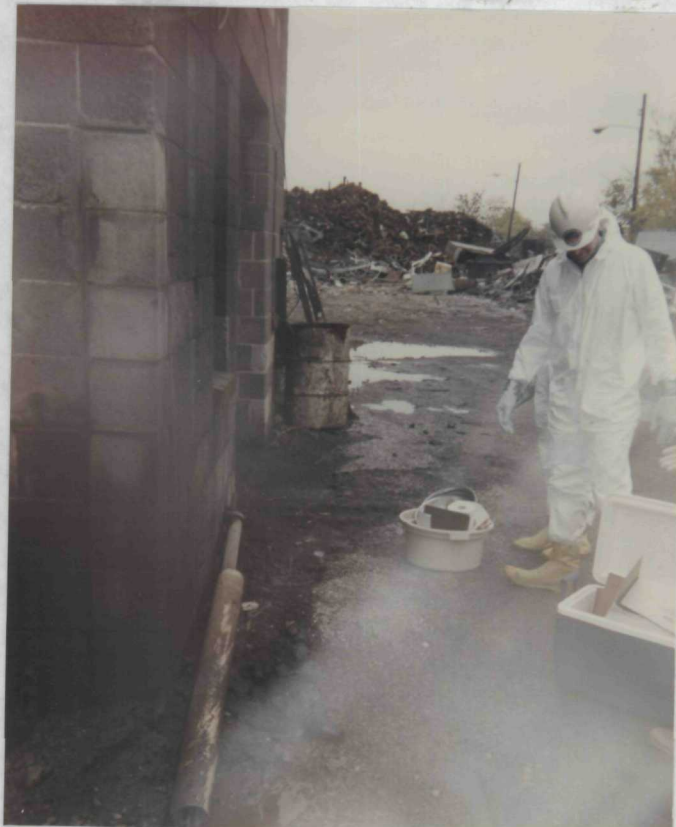
SAMPLE ID
(if applicable): S01

DESCRIPTION: View of yard 1

where sample S01 was taken.

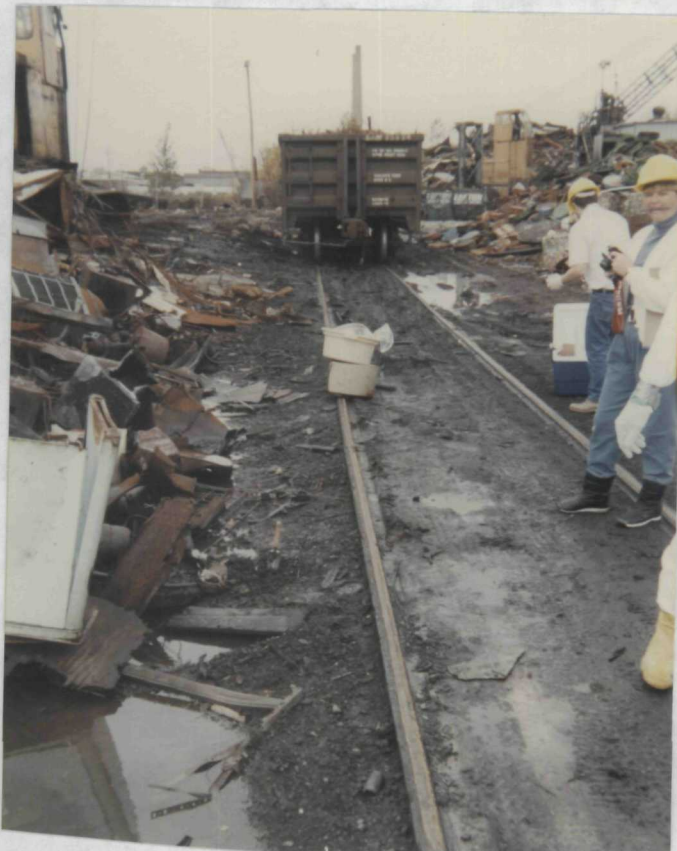
SAMPLE ID
(if applicable): S02

DESCRIPTION: View of yard 2

where S02 was taken.

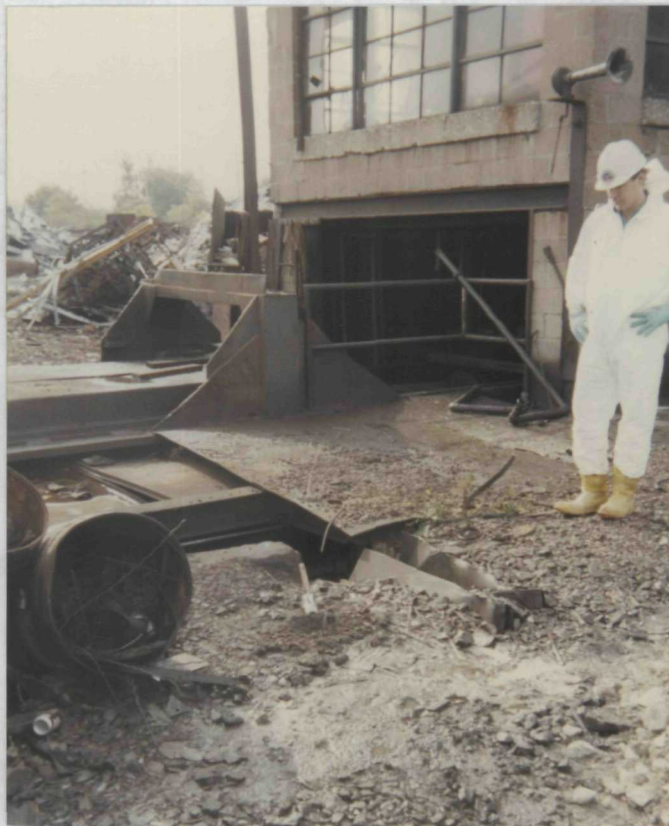
SAMPLE ID
(if applicable): S03

DESCRIPTION: Area within yard 1
where S03 was taken, north of
the big press.

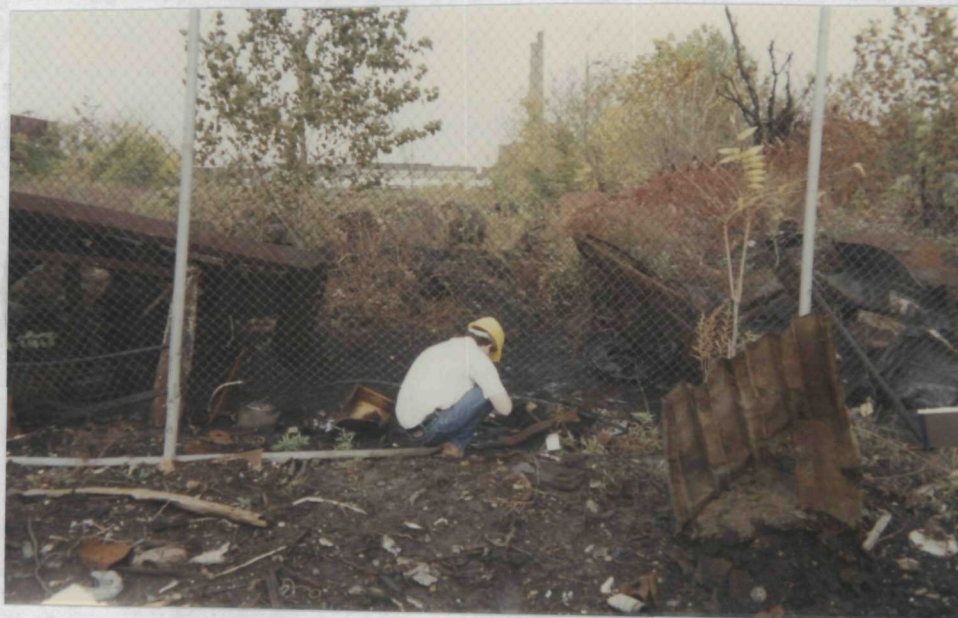
SAMPLE ID
(if applicable):
S04

DESCRIPTION: Area where S04 was taken. The Lefton property ends at the fence
line. There is however, debris and stained soil on the other side of the
boundary.

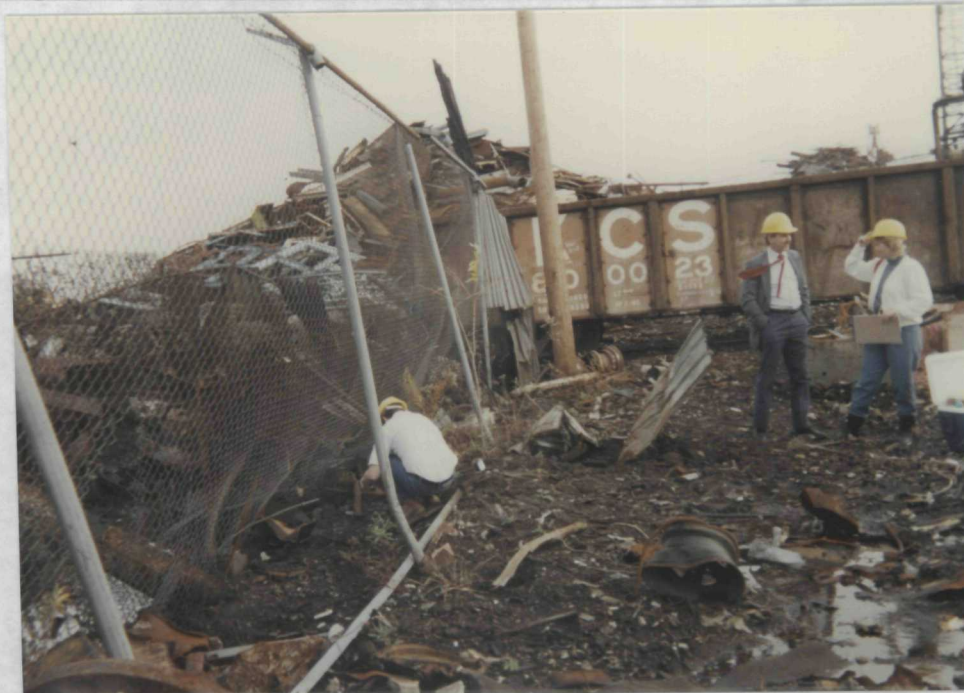
SAMPLE ID
(if applicable):
S04

DESCRIPTION: View along fence line of Lefton property. Sample S04 was taken just outside of the property line to determine if contamination was migrating off-site.

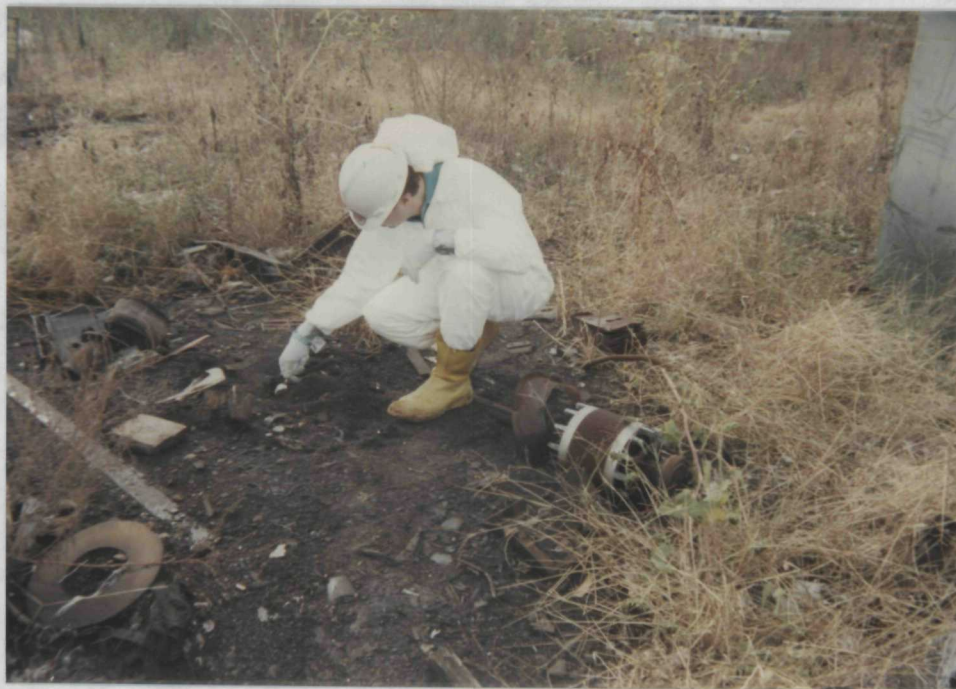
SAMPLE ID
(if applicable):
S05

DESCRIPTION: View of area within yard 1 where S05 was taken.

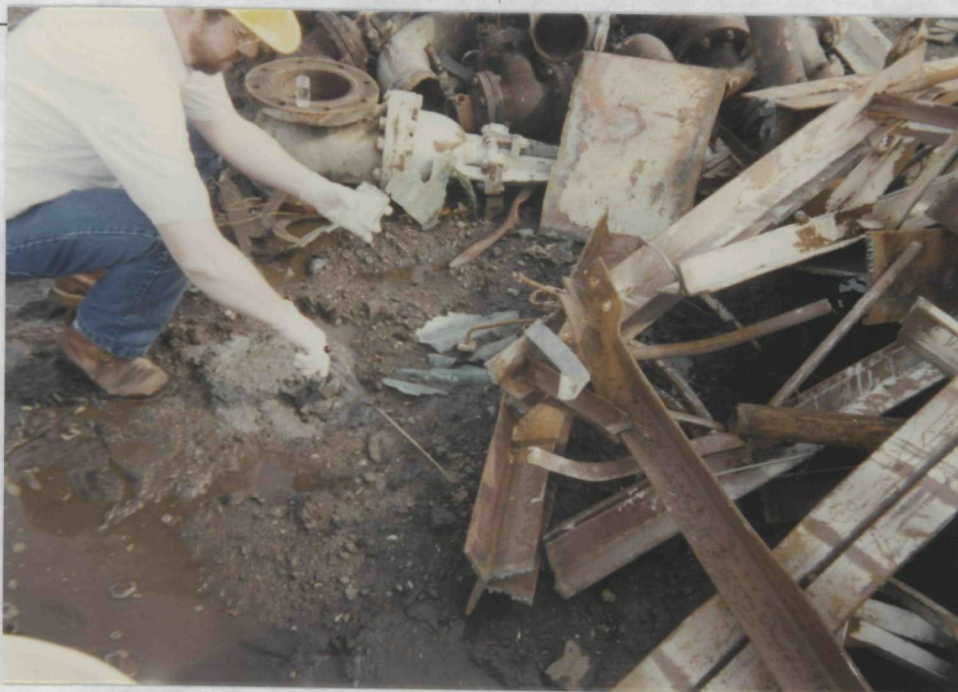
SAMPLE ID
(if applicable):
S06

DESCRIPTION: View of area within yard 2 where sample S06 was taken.

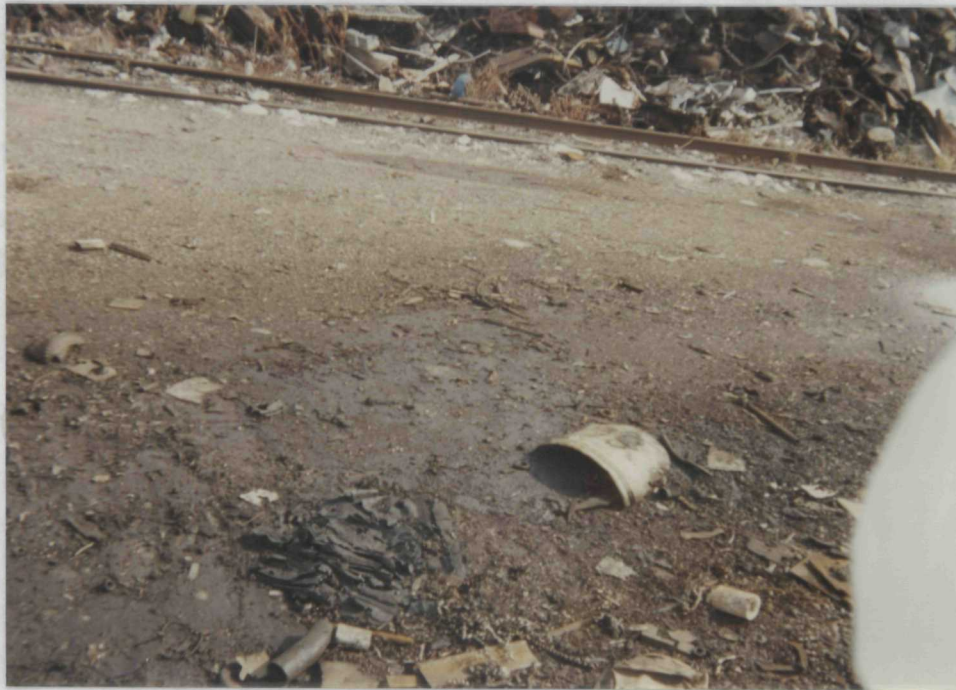
SAMPLE ID
(if applicable):
S07

DESCRIPTION: View of area within yard 2 where sample S07 was taken.

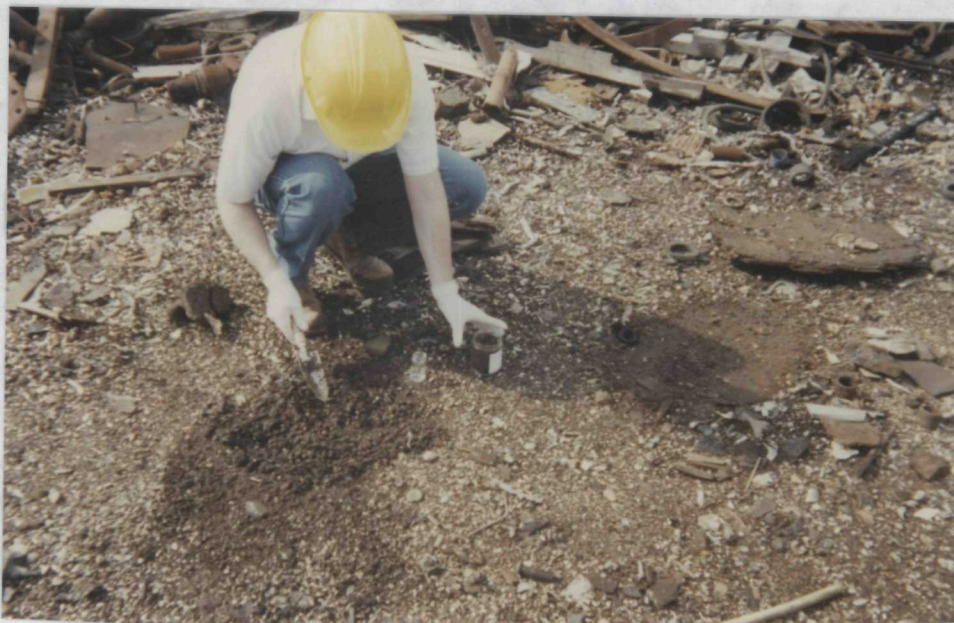
SAMPLE ID
(if applicable):
S08

DESCRIPTION: View of area within yard 2 where S08 was taken.

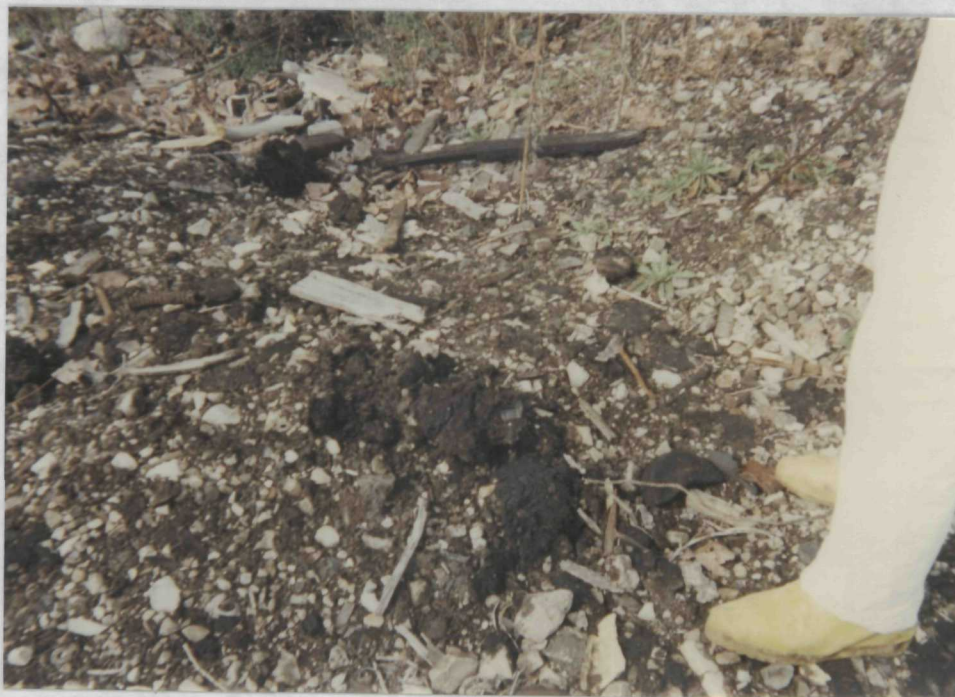
SAMPLE ID
(if applicable):
S10

DESCRIPTION: View of area where S10 and duplicate samples were taken.

TAT recommends a removal action at the Lefton site that would include fencing the fill area behind yard 2 followed by excavation and disposal of contaminated soils within this area.

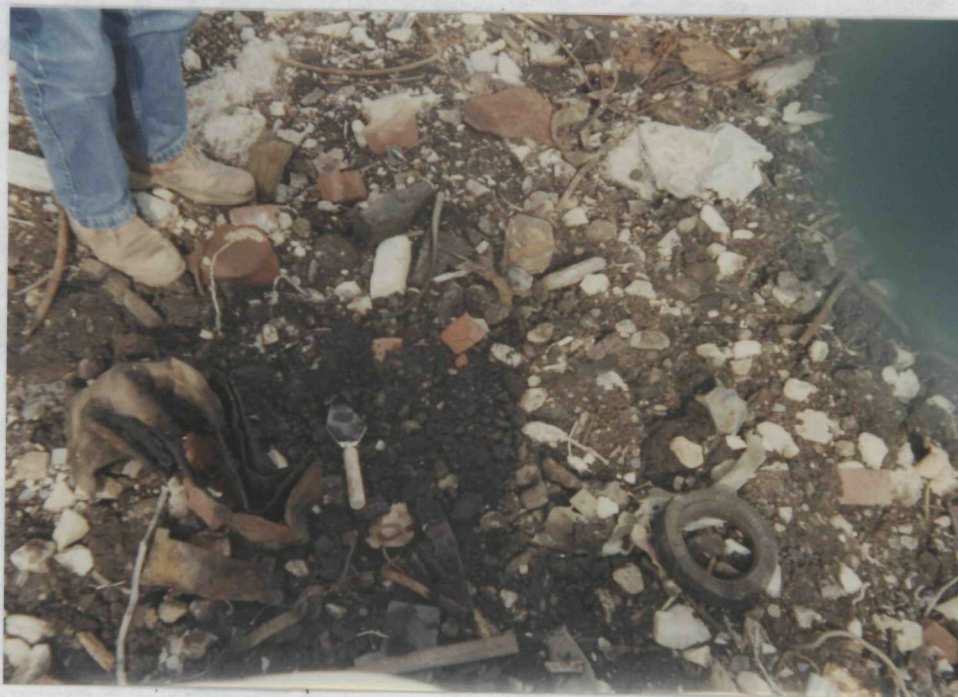
SAMPLE ID
(if applicable):
S11

DESCRIPTION: View of area where S11 was taken.

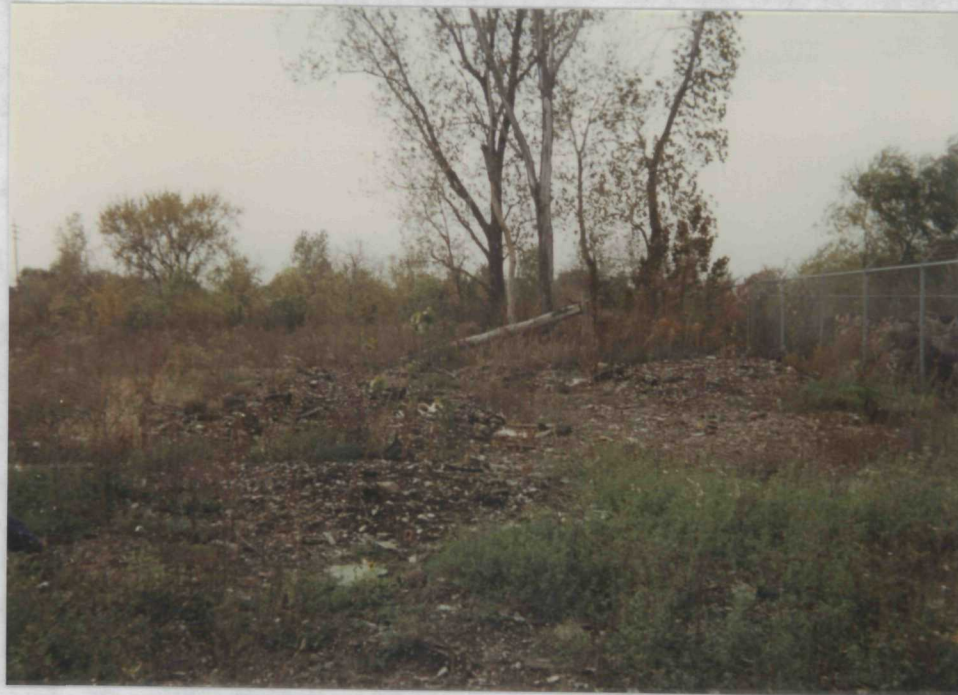
levels above 50 ppm in the fill area behind yard 2. This area is unsecured and easily accessible.

DESCRIPTION: View of area behind yard 2 where previous dumping allegedly took place.

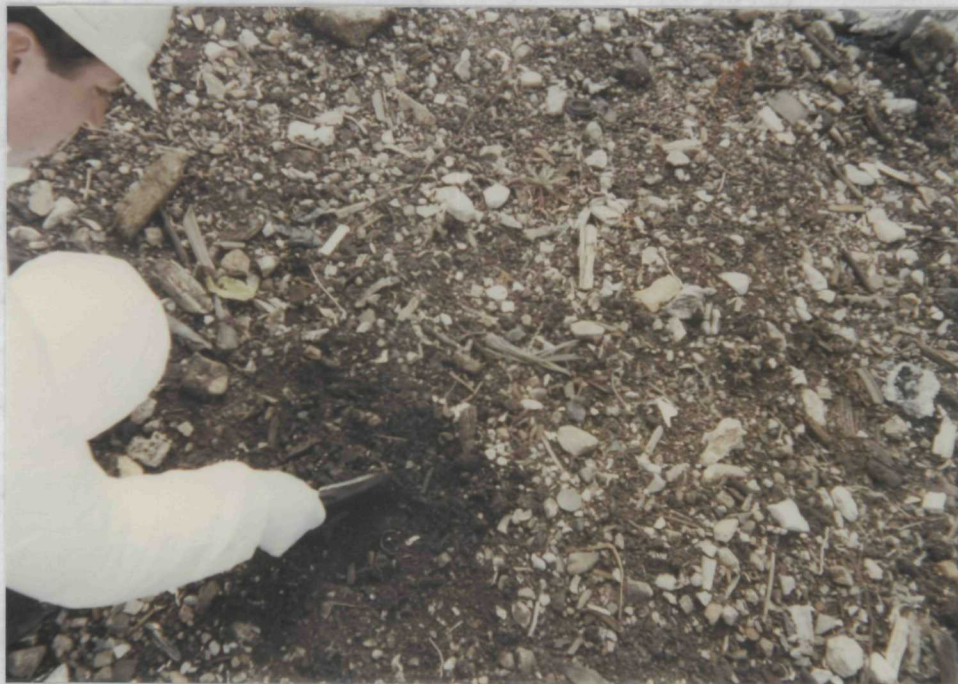
SAMPLE ID
(if applicable):
S12

DESCRIPTION: View of area where S12 was taken.
